KUMASI KEJETIA MARKET FIRE UPDATE

FIRE OUTBREAK AT THE KUMASI KEJETIA MARKET PHASE 1 AND MATTERS ARISING

1 Introduction

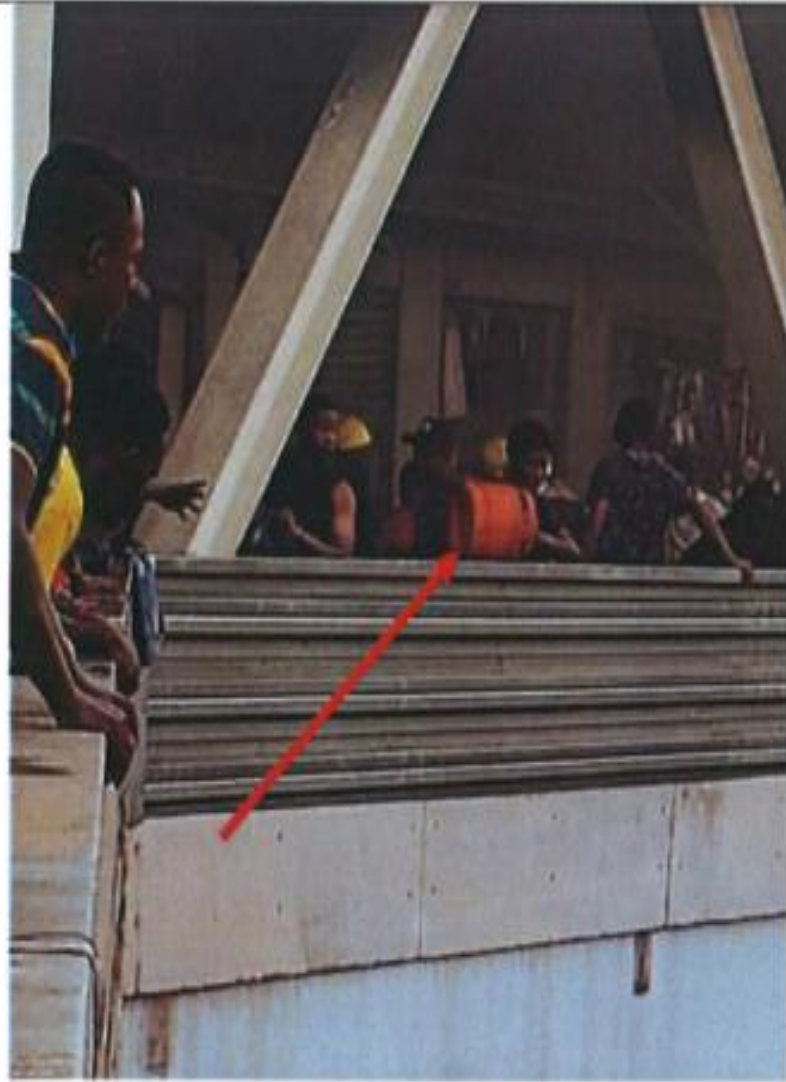
e. There were gas cylinders in this area of the fire that should not have been there

Figure 2.1- Gas cylinders being throw from the 1st floor

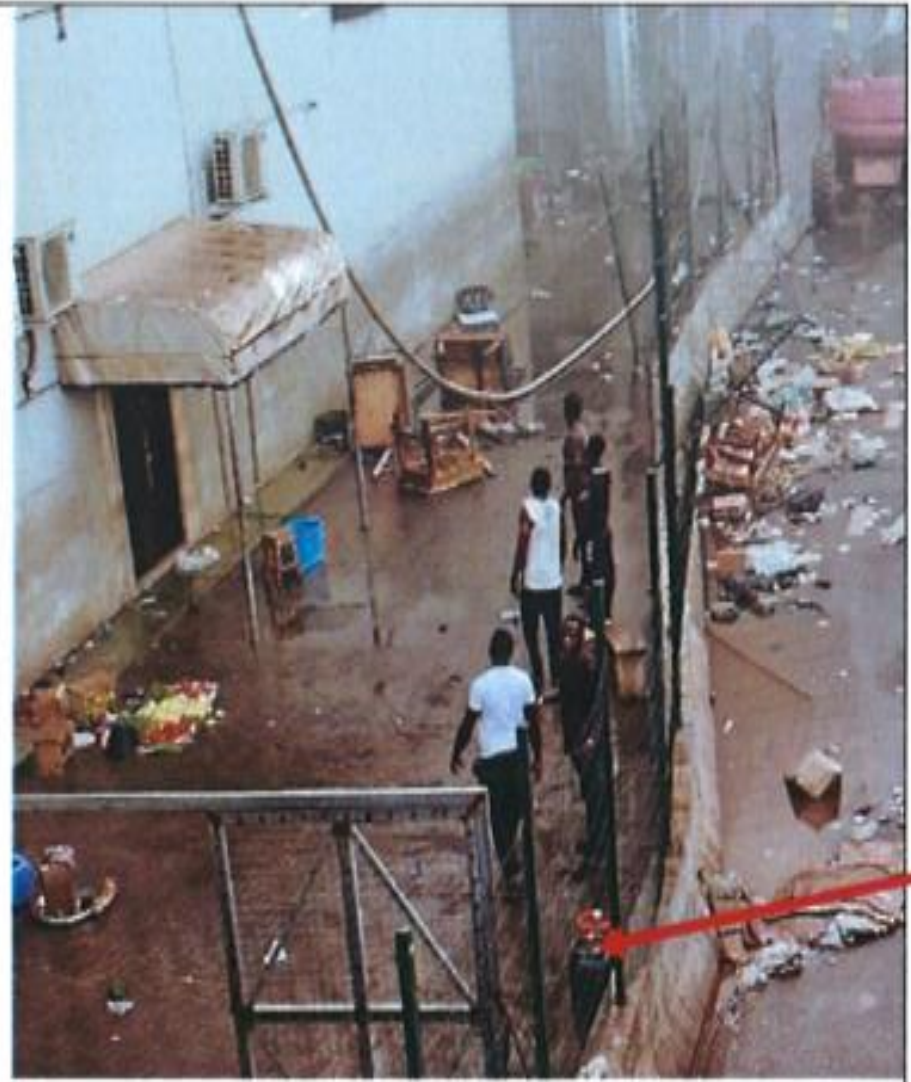
Figure 2.2- Gas Cylinders on the floor after being thrown down

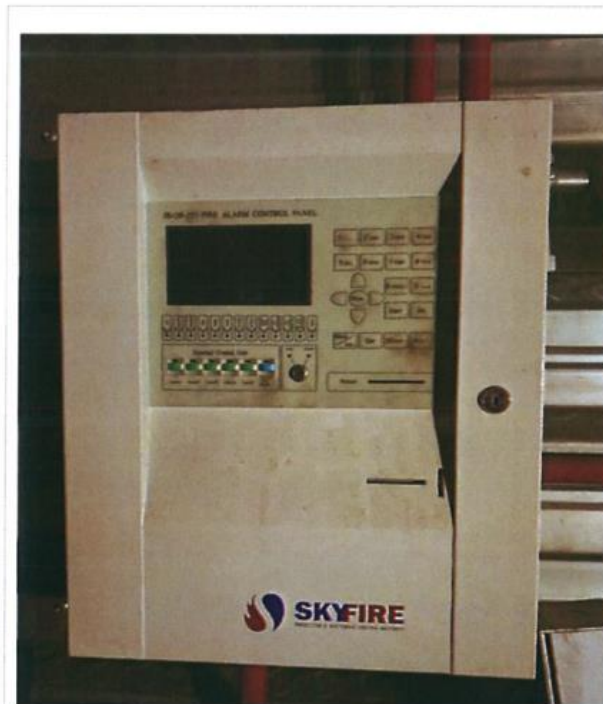
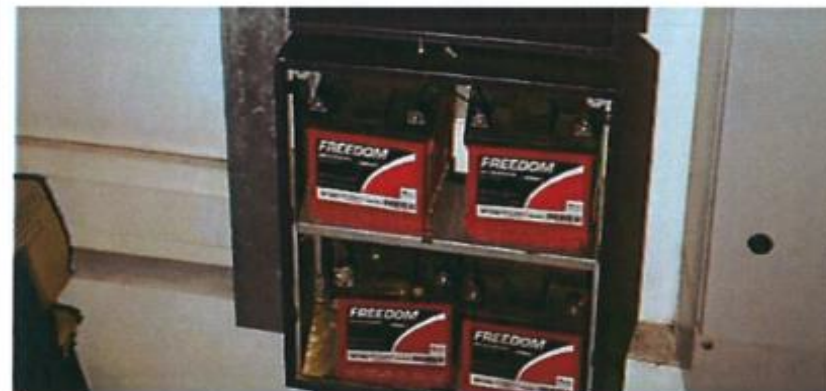
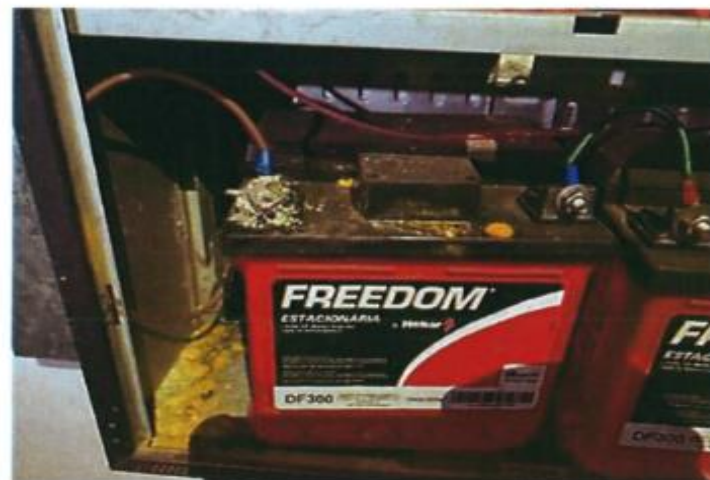
Figure 2.3 – Skyfire Alarm System Panel

- Review/repair/recommission the Fire Alarm and Detection System (Main and secondary panels and distribution) by a third party as recommended and previously advised by Contracta in the past.

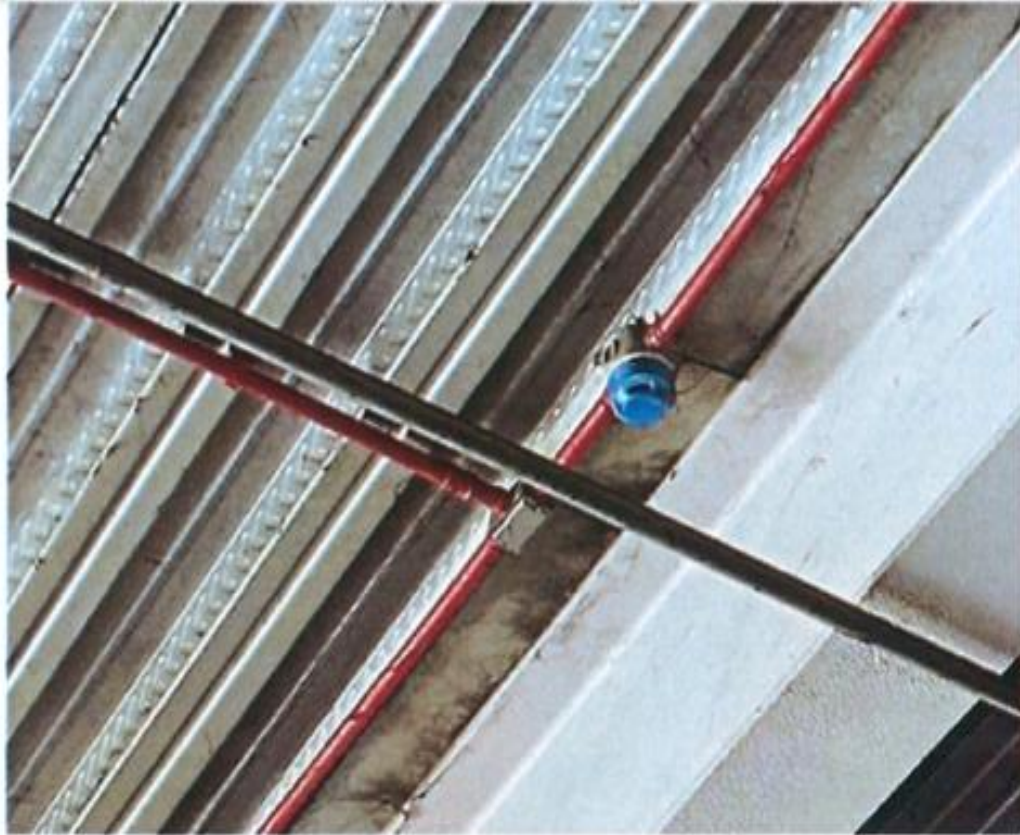
Figure 2.4 – Covered Smoke detectors

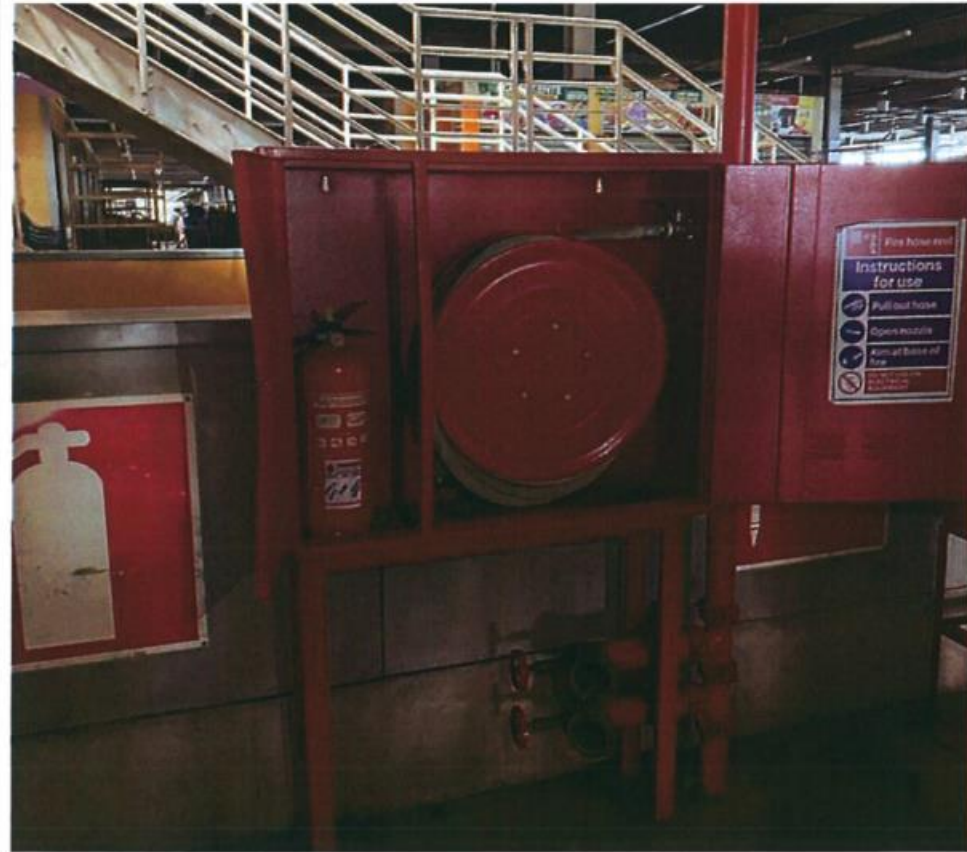
d. All the fire cabinets in the facility had in them, a DCP extinguisher and fire hose and properly labelled (Figure 3.3).

Figure 2.5 – Fire Cabinet

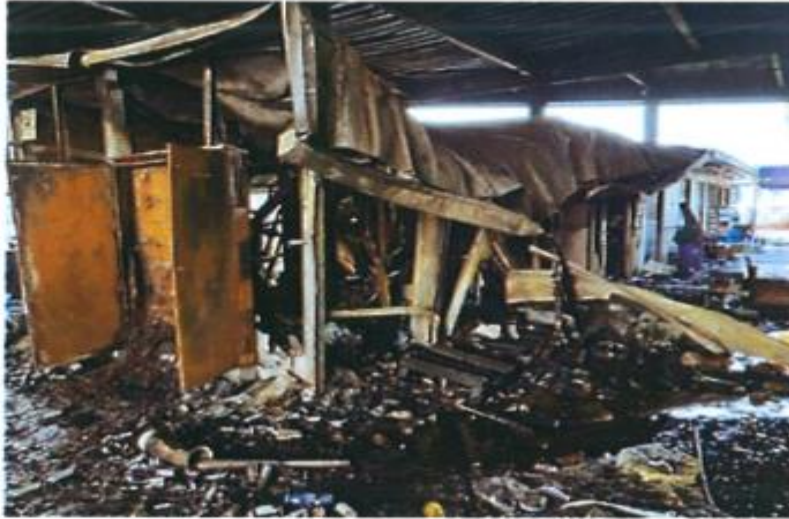
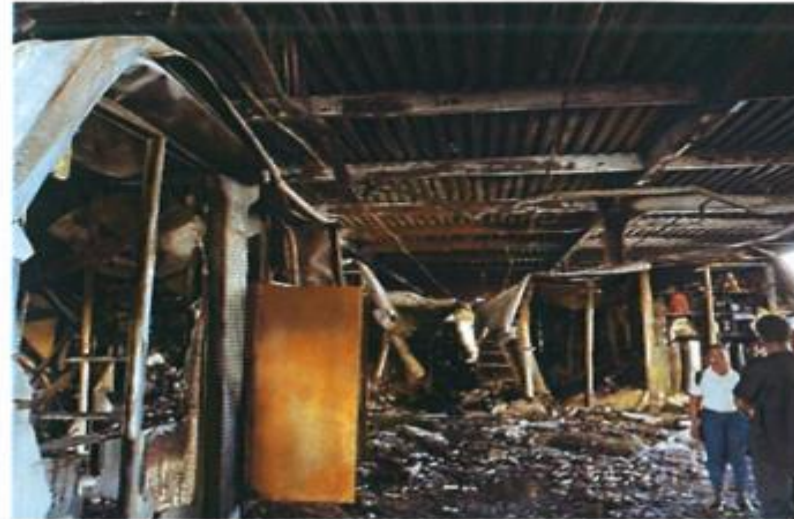
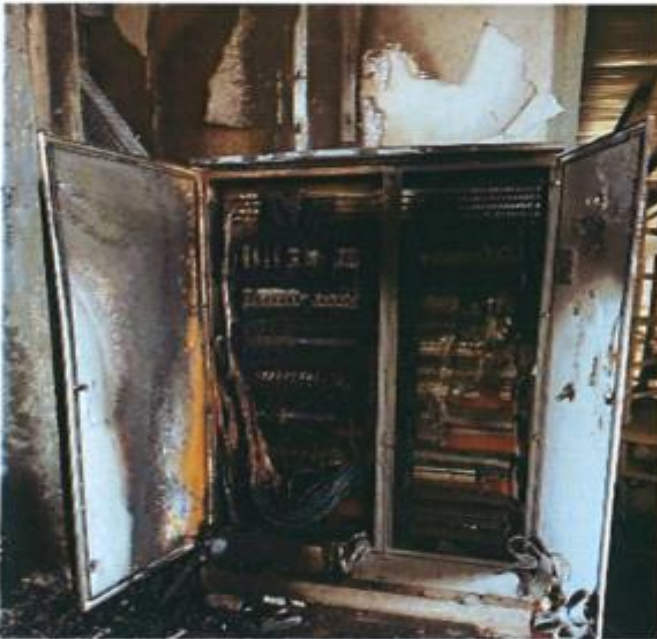
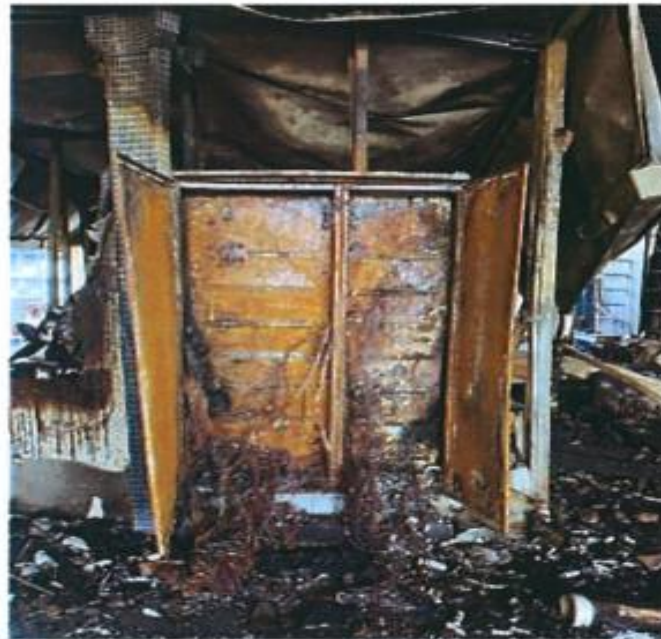
Despite the efforts of the firefighters, the fire caused considerable damage to the structure of the fire affected area of the building. The flames destroyed goods and properties whilst the upper area of the market structure building suffered from significant smoke staining to the soffit of the roof covering.

By our technician's account, the incident damaged about 42 shops in the affected area, 12 with severe damages.

Figure 4.1 - The aftermath of the fire incident and the damaged structures

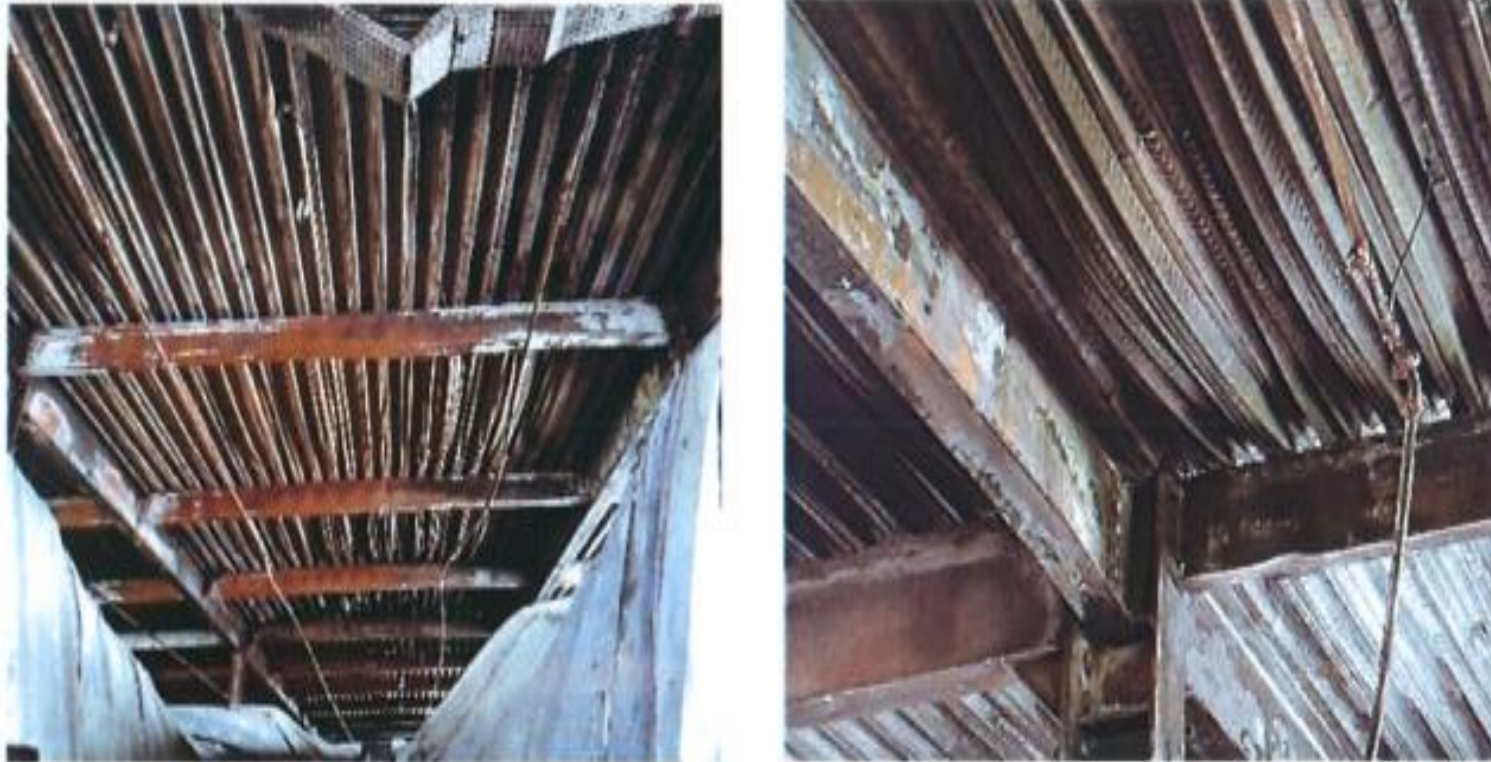
- Some beams were affected by the fire and got visually bent. A deeper inspection is recommended to confirm the "level of structural damages" and the impact of the damage on the integrity of the structure.
- Some portions of the steel deck at the 2nd level floor slab got visually damaged by the fire. A more detailed inspection is recommended to confirm the "level of the damage" and the impact of this referred "damage" on the integrity of the structure.
- It was impossible to confirm if any other damage affected the concrete slab because the area was full of debris and with a layer of water on top.
- The structure of some stores was affected in the surrounding area, where the fire started.
- Concrete has been exposed to high temperatures for a long time, and specialists should conduct a more detailed investigation with proper equipment to confirm its integrity.

Figure 5.1- Damaged Steel deck and beam

Notwithstanding the above observations, it is recommended that a more detailed structural survey be carried out by specialists with special survey equipment to check and determine the depth of any damage and the implications for the integrity of the structure.

- X-Ray of the main structural elements (columns and beams) to check their retained structural integrity after such a long exposure to fire.
 - Strength tests on the slab concrete to ensure its original characteristics were not affected by the long-term fire exposure.

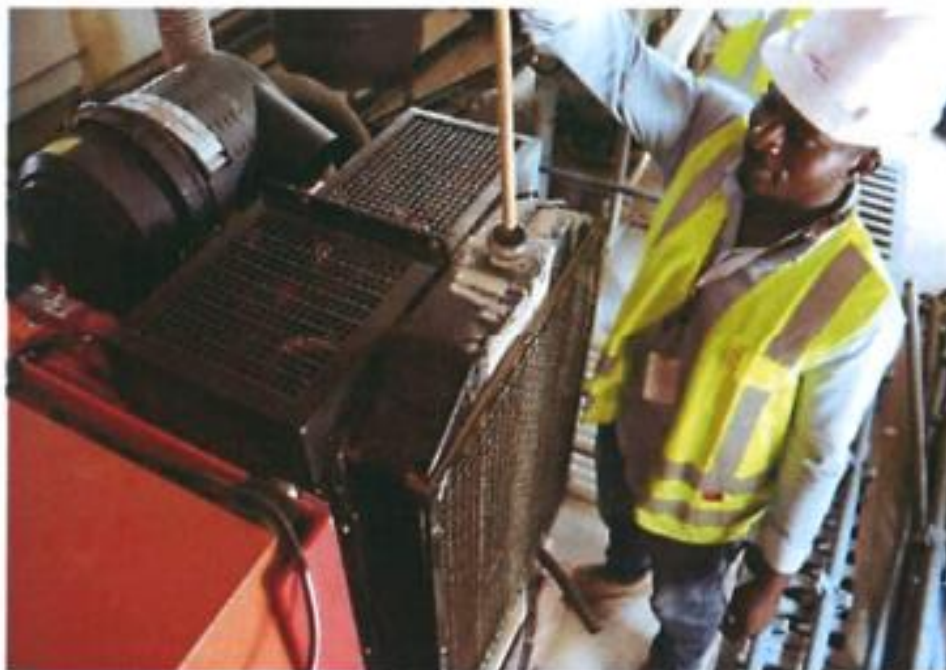
- The jockey pump was turned off, although the panels were energised.

- Complete physical isolation of the affected area (connection) until the inspections and test results were concluded.
- Review/repair/recommission the Fire Pumps (mechanically and electrically) by a third party as recommended and previously advised by Contracta in the past.
- Remove any material unrelated to the fire pump's operation from the Pump Room.

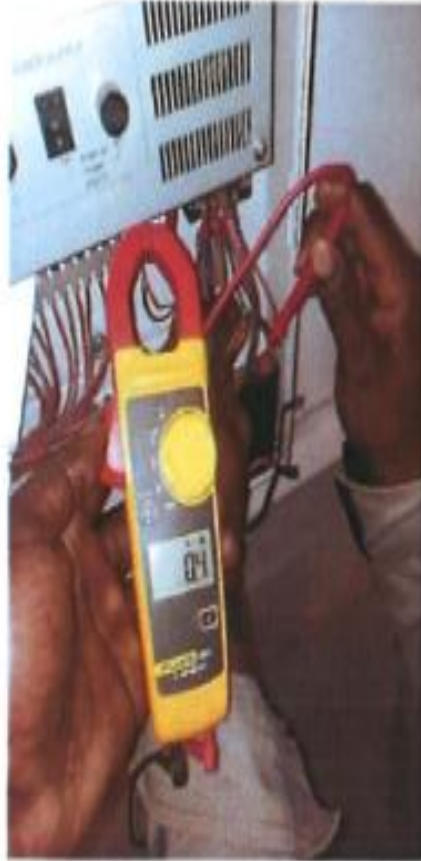
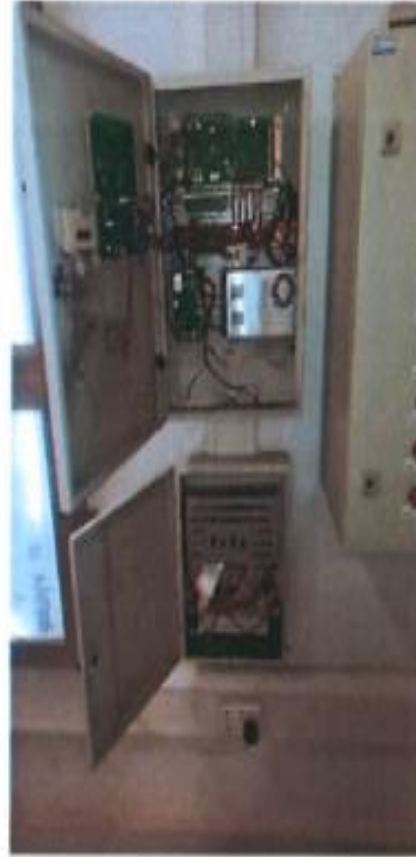
The Firefighting and Fire Detection distribution systems got damaged in the area affected by the fire and should be replaced.

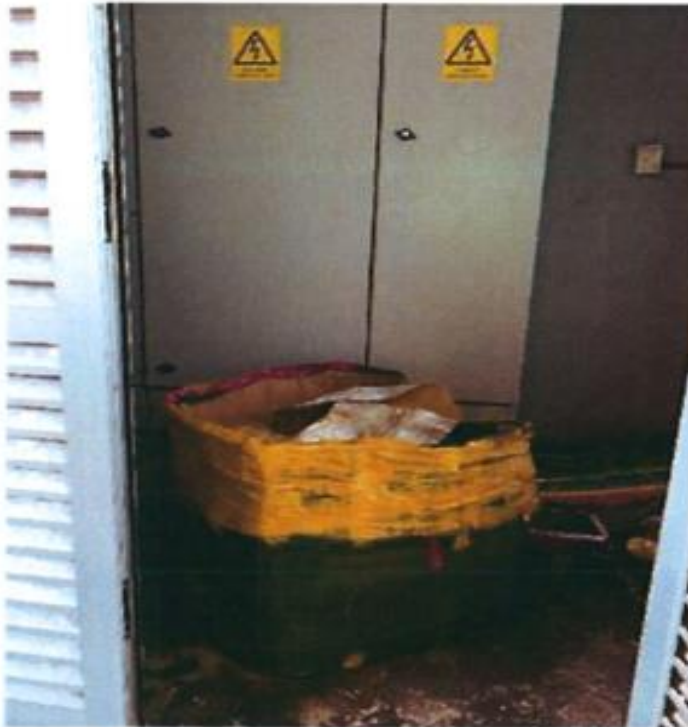
Some Electrical panel rooms have been used as a warehouse, creating obstacles to access the equipment. Using these rooms for storage is a serious fire risk and the practice must cease.

Figure 5.10- Electrical Room being used as storage

- Visit all the Technical Rooms removing all material unrelated to the operation of the equipment installed on them.
- Detailed analysis carried out by a specialised and well-equipped company with experience in this kind of incident to indicate the proper extension of isolation on the MEP installations at the connection area and its surroundings (at least a 100m radius) for partially reopening the premises:

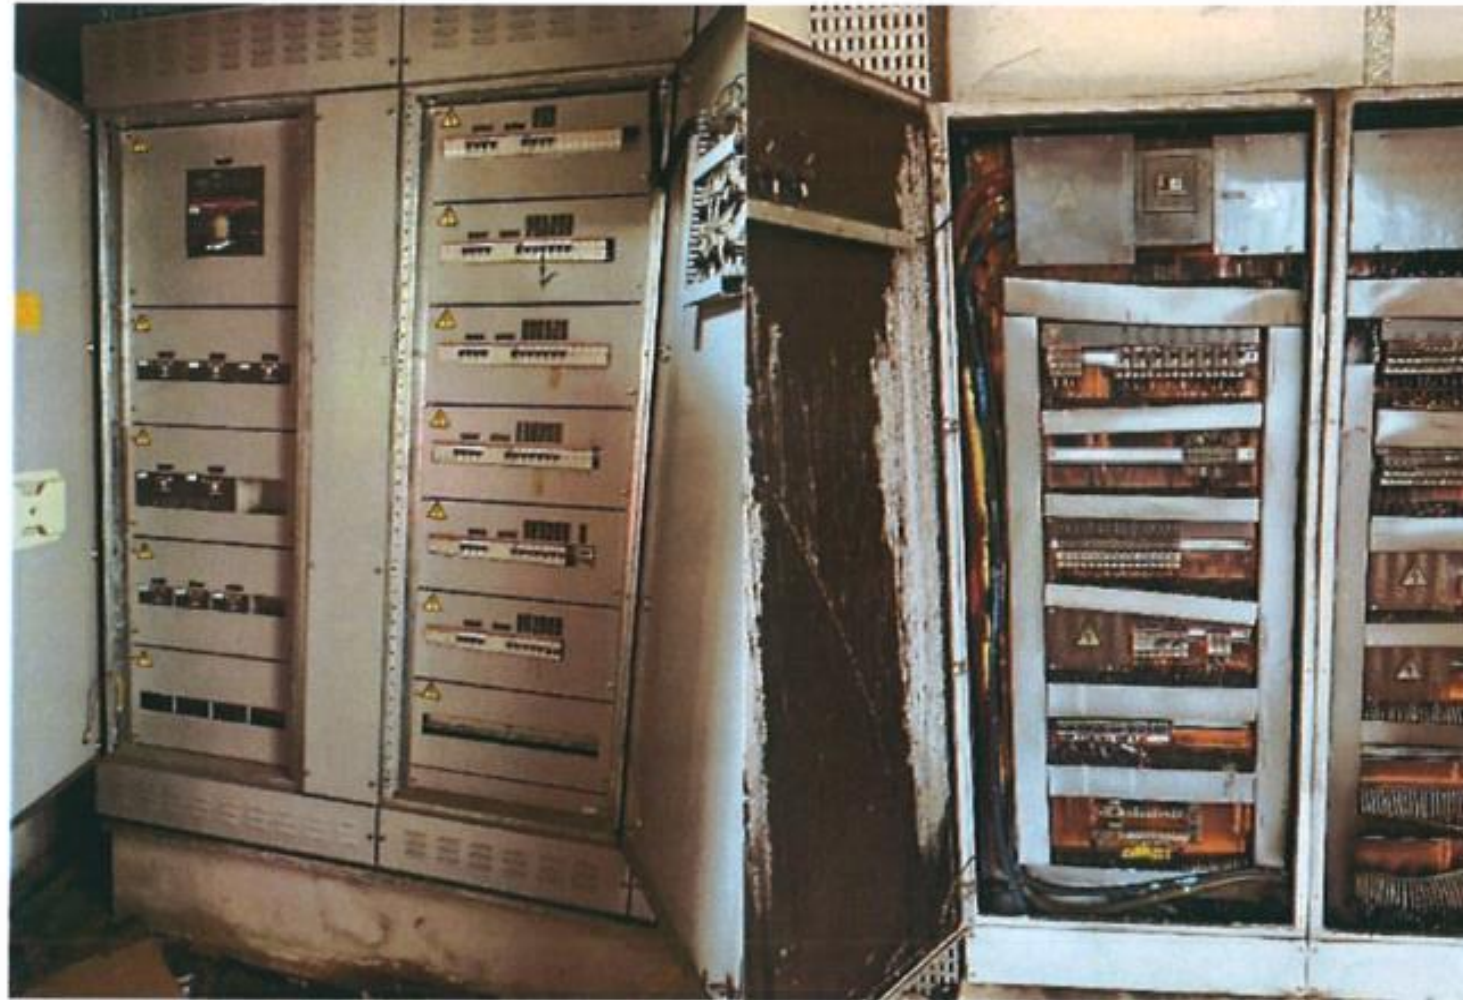
During the inspection, it was identified that the main panel breakers that supplied power to the affected area (connection) were off, suggesting that this is why most breakers in the block panels didn't turn off.

Photo of the Main Panel (Breakers Off)

Photo of a block panel (Breakers on)

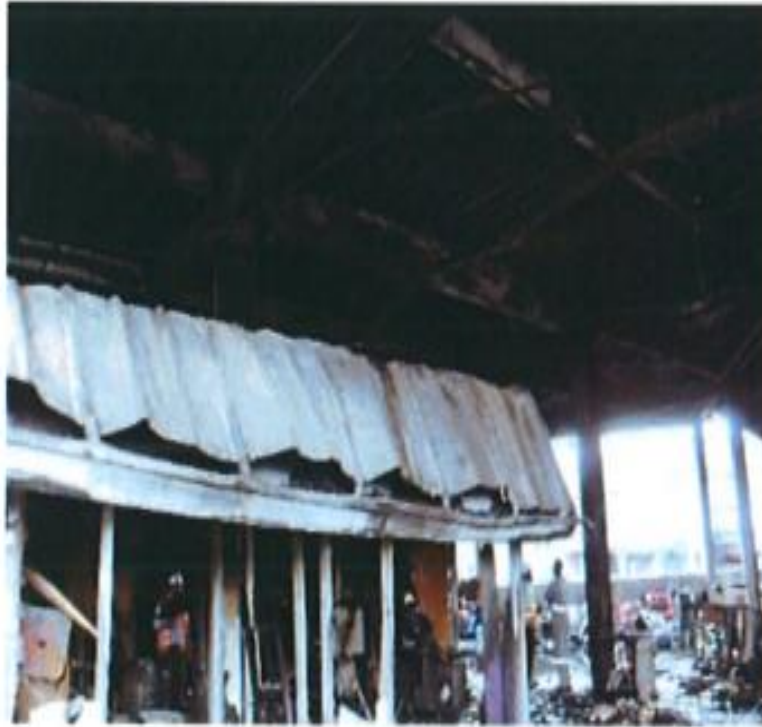
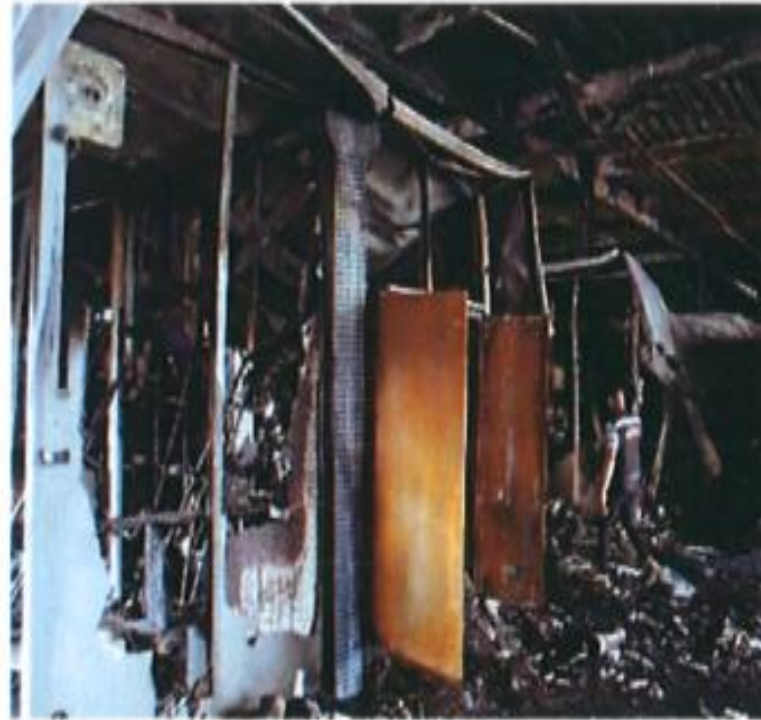
All pipes and supports got damaged in the affected area by the fire and should be replaced.
